# Impacts of Storm Hercules in Southwestern Europe

**Abstract.** The aim of this study is to analyze the impacts of the Hercules storm in southwestern Europe. The storm occurred from January 5 -7, 2014. A brief characterization of the storm was conducted and the witnesses' accounts were compiled, complemented with field survey before and after the storm. The results show that this event had origin in an intense low pressure system that hit Portugal, Spain, France and the UK. The system triggered strong sea waves with long periods, run-ups between 6 to 9 m, and inundation depths of less than 1 m. The effects on the European coastlines showed some weaknesses in the spatial planning management: (i) the fact that a wave train restricted to the beaches, front streets, ports and marinas caused significant damage; (ii) some people ignored the emergency management authorities, putting themselves in a risk situation.

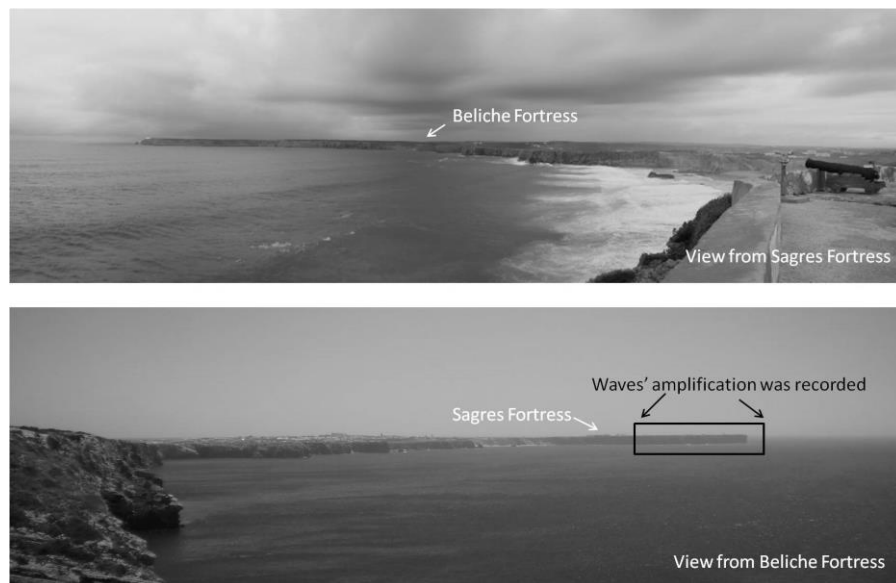
**Fig .5** Field survey at Sagres: upper photo shows the view from the Sagres Fortress. Photo taken on November 1, 2011; lower: photo shows the view from the Beliche Fortress. Photo taken on August 20, 2014

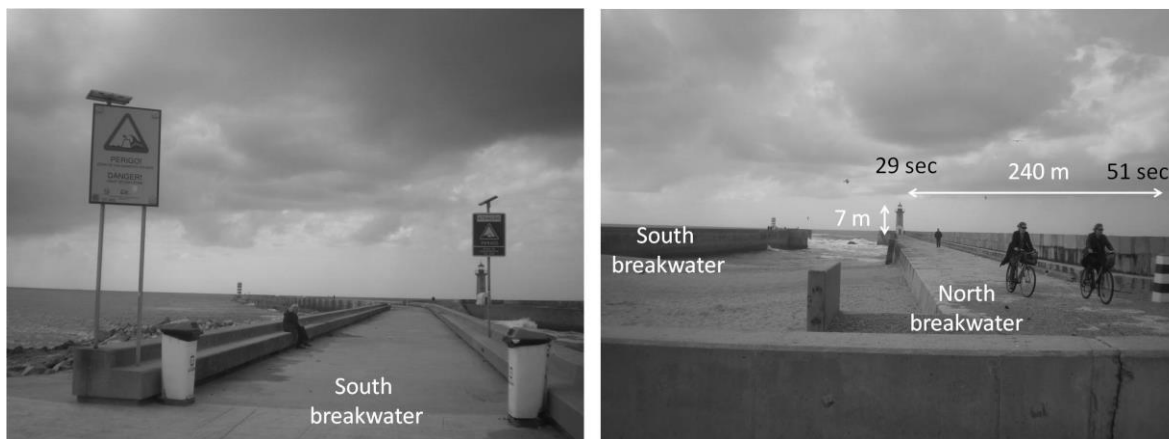
Video [19] showed the wave hitting the lighthouse, amplifying till about 3 m above it, at 29 seconds, and at 51 seconds was reaching the end of the north breakwater. The field survey results show the lighthouse is about 7 m high (fig 7), and the north breakwater is 4.7 m high. Therefore, the run-up at the lighthouse was about 14.7 m. In addition, the north breakwater is about 240 m long, allowing calculating the velocity of the wave as 11 m/s (39.3 km/h).

**Fig. 7** Left photo: The south breakwater. There are two warning signs about the danger of waves overtopping the breakwater, in Portuguese and English. Right photo: the north breakwater is 4.7 m high and about 240 m in length. The lighthouse is about 7 m high. A video [19] showed the wave hitting the lighthouse about 3 m above the lighthouse, at 29 seconds, and at 51 seconds was reaching the end of the breakwater
